INTERMOUNTAIN POWER SERVICE CORPORATION

Engineering Test and Inspection Sheet

Equipment Burners Unit # 1 Test/Inspection Date April 15, 1994
 Inspector Garry Christensen, Cecil James Responsible Engineer (Initials) _____

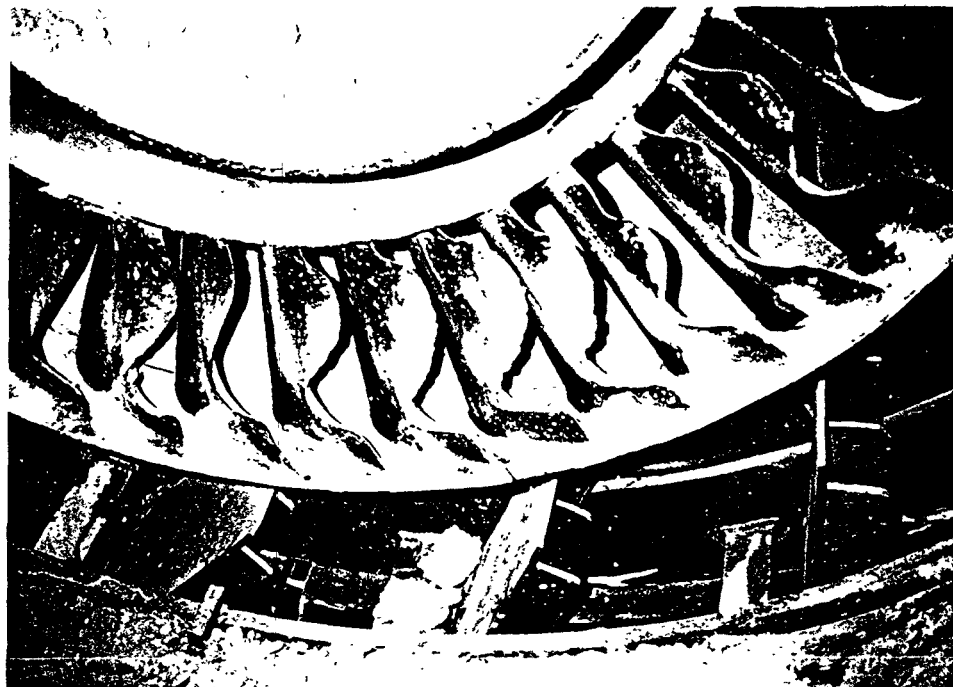
D4, D5, D6	Seized up outer register vanes.	
H2	Stabilizer too deformed for service, PHOTOS 5, 6, 7. Stabilizer replaced.	
H3	Stabilizer too deformed for service, PHOTO 8. Stabilizer replaced. Seized up outer register vanes.	
H4, H5	Nozzle seam weld split approximately 6 inches.	
H6	Stabilizer is starting to blossom.	
C1	Nozzle out of round.	
C2, C5, C6	Seized up outer register vanes.	
C4	Loose outer register shroud. Shrouds reattached with C2: 6-11/16", C5: 6-1/16, C6: 6-1/16" air gaps.	
G2	Stabilizer bowed out at bottom, PHOTO 9. Nozzle has dropped and pushes the stabilizer as it expands.	
G5	The weld between the CS barrel and the SS tip has cracked, PHOTO 10. Nozzle has dropped down onto the stabilizer, PHOTO 11.	
	Nozzle is out of round and resting on stabilizer, PHOTO 12.

PHOTO 5: Deformation of H2 stabilizer vanes due to overheating.

PHOTO 6: Distortion of the H2 stabilizer vanes.

PHOTO 7: Loss of H2 stabilizer functionality due to distortion.

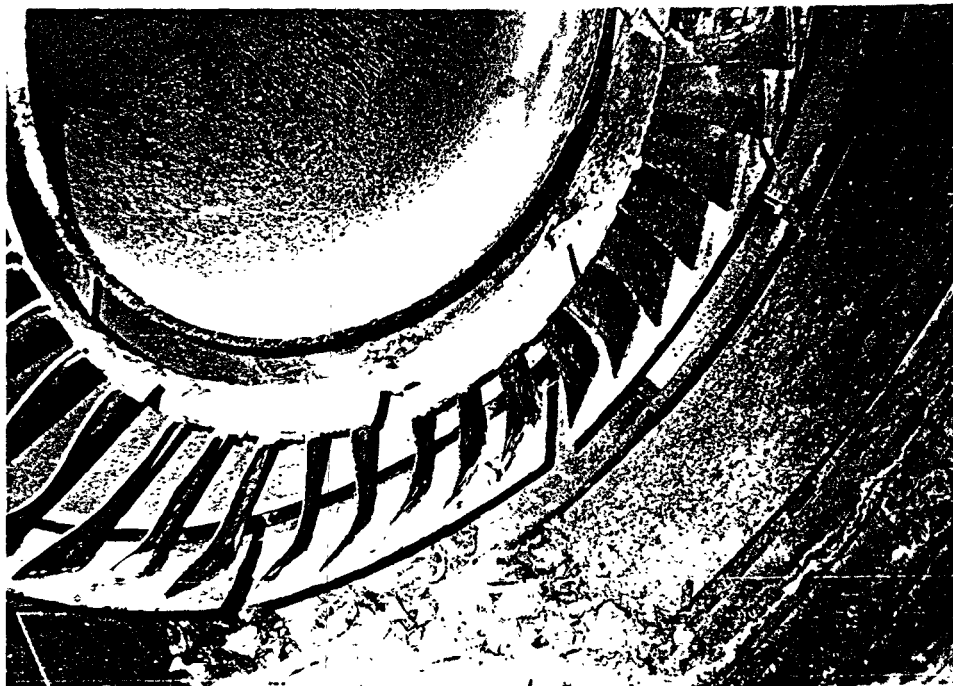
PHOTO 9: C4 stabilizer being pushed out by the nozzle.

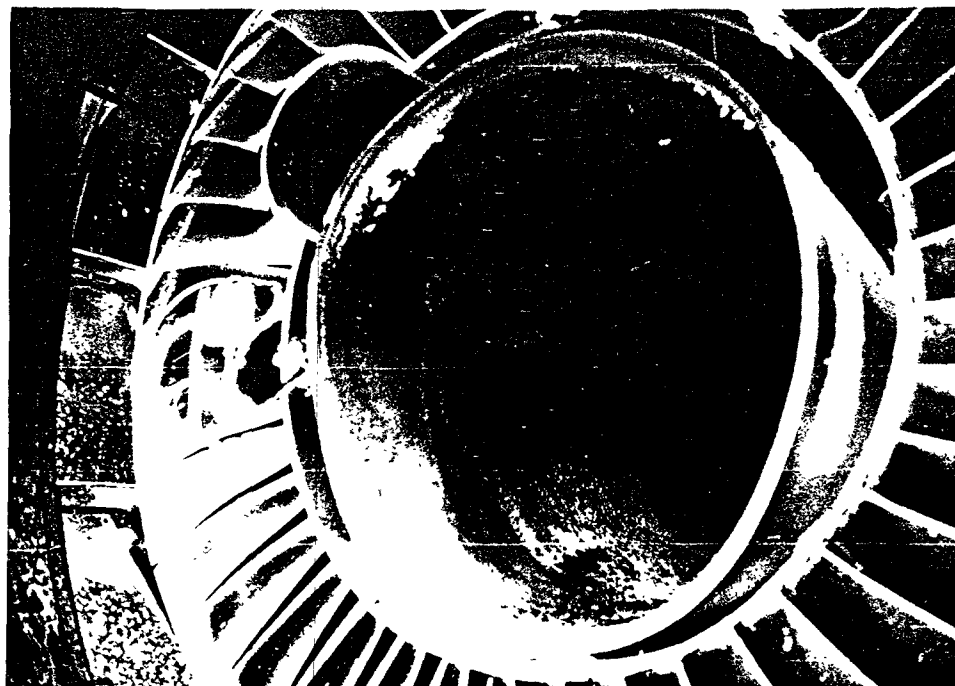
PHOTO 11: G2 nozzle impinging on the stabilizer may eventually cause the same problem seen in photo 9.

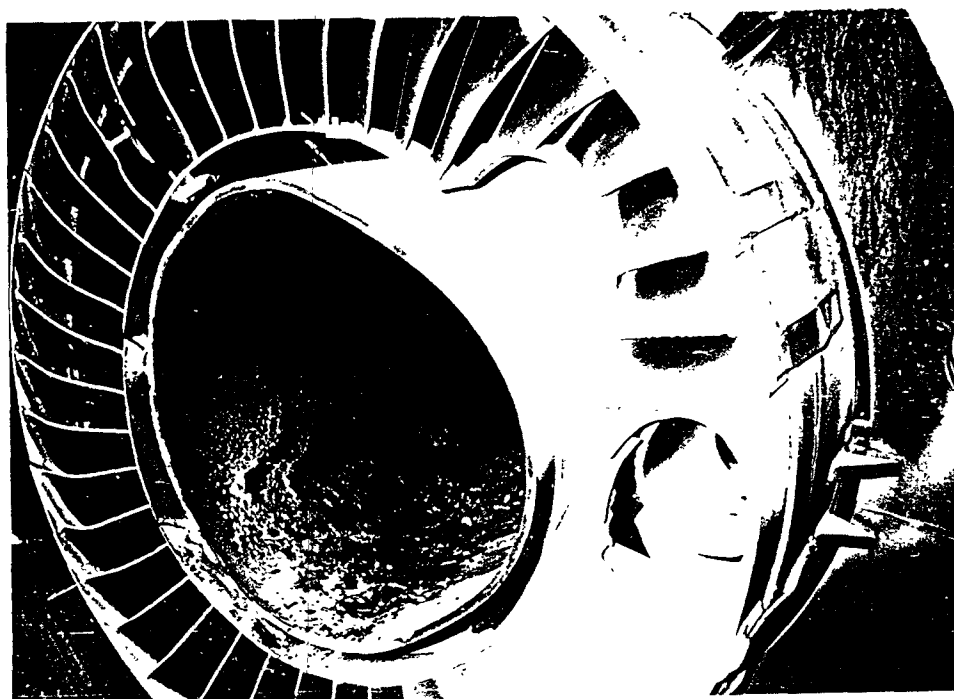
PHOTO 12: G5 nozzle impinging on the stabilizer may eventually cause the same problem seen in photo 9.
